4.2 CANAL HEADGATE STRUCTURE

4.2.2 Existing Conditions and Deficiencies

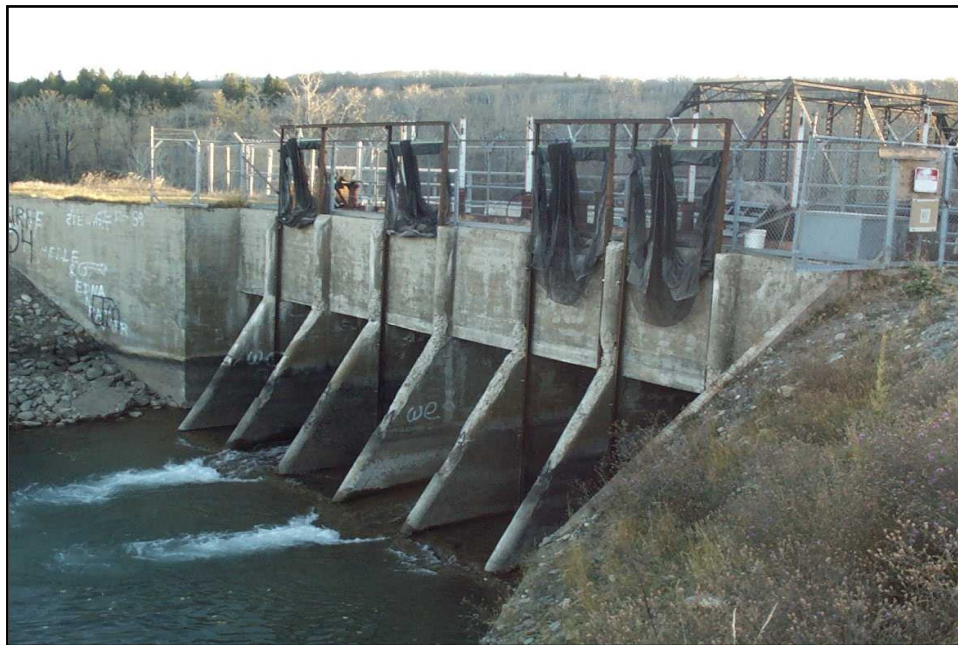
The St. Mary Diversion headgate structure was completed at the same time as the diversion dam in 1915. The headgate structure is contiguous with the dam on the west abutment (Figure 4.2.1).

Figure 4.2.1 Looking at downstream end (canal side) of headgate structure. Diversion dam is located behind headgates (10/13/04).

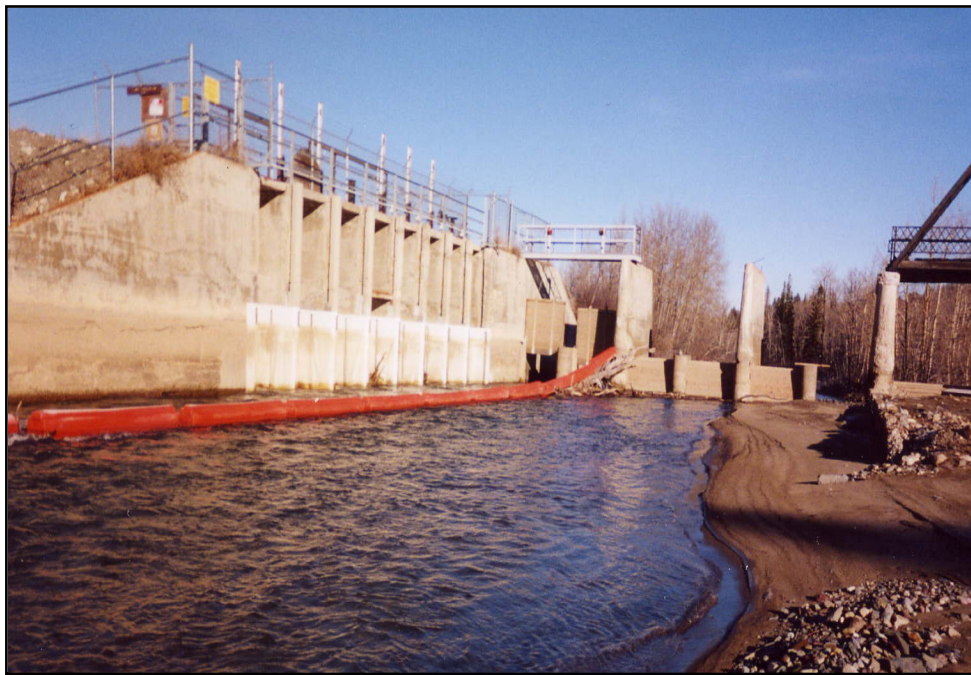
The structure contains eight steel slide gates. Each gate is 5 ft. x 5.5 ft in size. Hoists located on top of the structure are used to open and close the gates. The main gate wall is about 59 feet long and 19 feet high. A wing wall extends upstream about 65 feet above the headgates (Figure 4.2.2). A concrete channel extends from the dam along the front of the gates and transitions to the original channel about 30 feet upstream of the last gate. Original plans indicate this channel was 20 feet wide, but the visible portions of the channel wall on the east side suggest the channel is closer to 57 feet wide. The gates were originally equipped with mechanical operators. These have been replaced with hydraulic operators on Gates 2 through 7. Gate 1 remains a mechanical operator. Gate numbering starts with 1 on the north end of the structure.

Figure 4.2.2 Upstream view of headgates showing trash boom, electric fish barrier, and dam sluiceways (11/11/04).

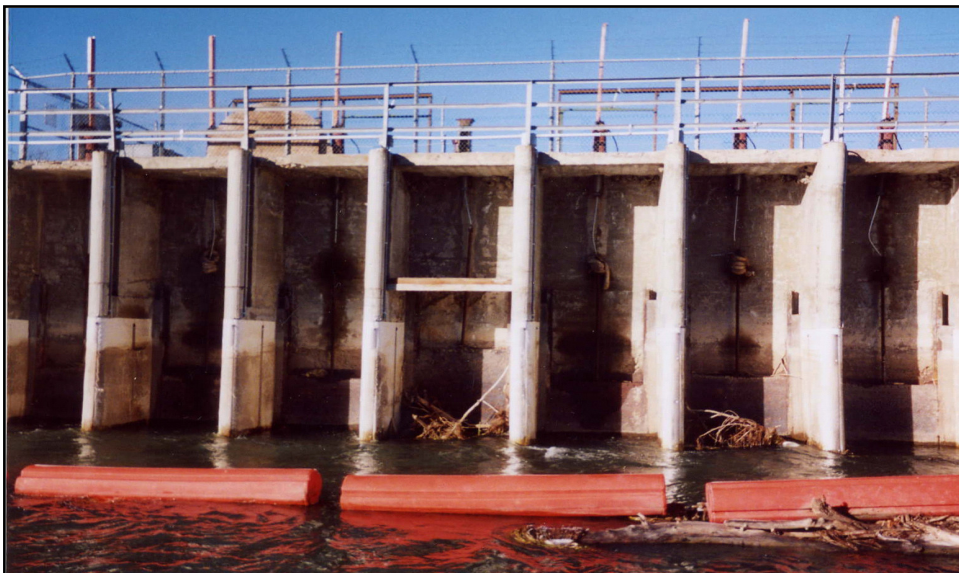
Debris is a problem for gate operation and for the electric fish barrier. A floating boom was installed upstream of the electric fish barrier and gates to divert debris; however, debris still impacts gate operations (Figure 4.2.3).

Figure 4.2.3 Upstream view of gate openings (11/11/04).

The bottom member of gates 1, 4, 6, & 7 were reported to be bent and cracked in the 2003 report. Debris is currently preventing total closure of gates 3 and 5 and these gates are leaking badly (Figures 4.2.3 and 4.2.4). The remaining gates had some leakage, but not as bad.

The gates at a minimum need repair so that they can completely shut off the flow of water during the off-season. Flow of water in the canal during the winter aggravates concrete deterioration problems caused by freezing at the headgates and at the Kennedy siphon and check structure. Debris will continue to be a major operational problem once the gates are repaired unless some type of debris barrier is installed. Currently there is no way to safely remove the debris. The floating boom deflects some debris but also becomes entangled with trees and larger debris. There is no way to clear the boom without entering the stream.

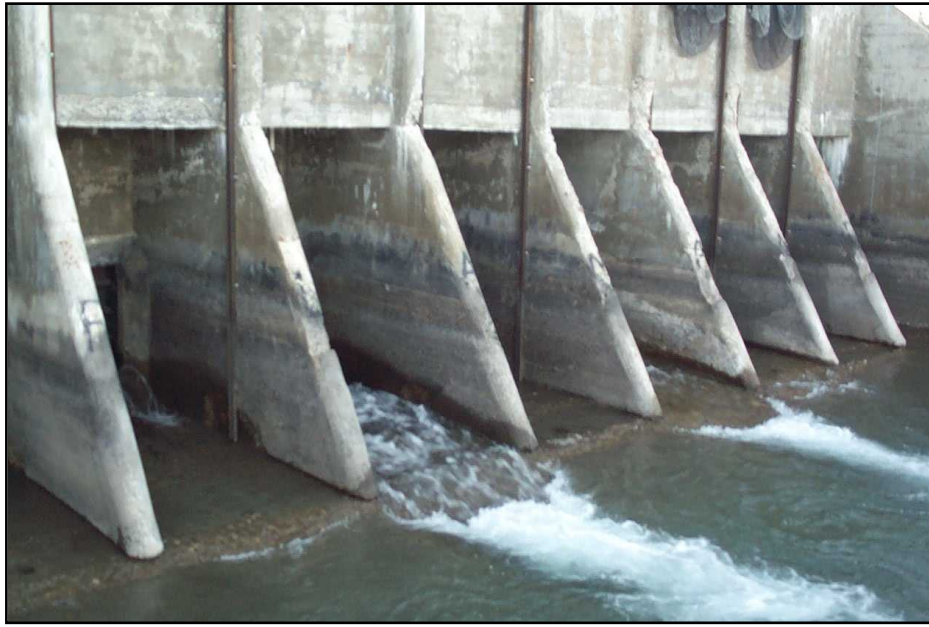
Figure 4.2.4 Downstream view of headgate structure. Note heavy leakage through Gates 3 and 5 (10/13/04).

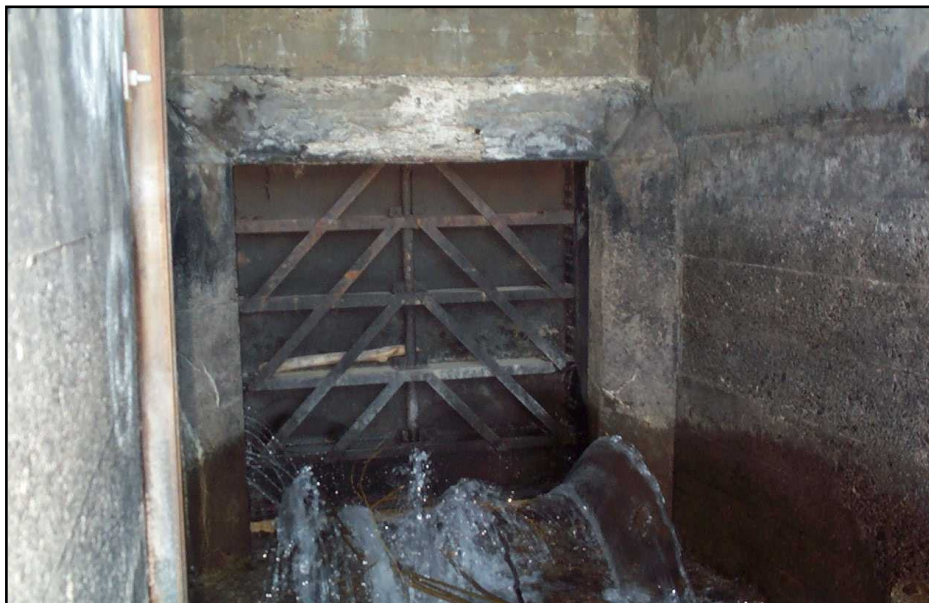
Figure 4.2.5 Close-up (downstream) of heavy leakage and debris on Gate 3 (10/13/04).

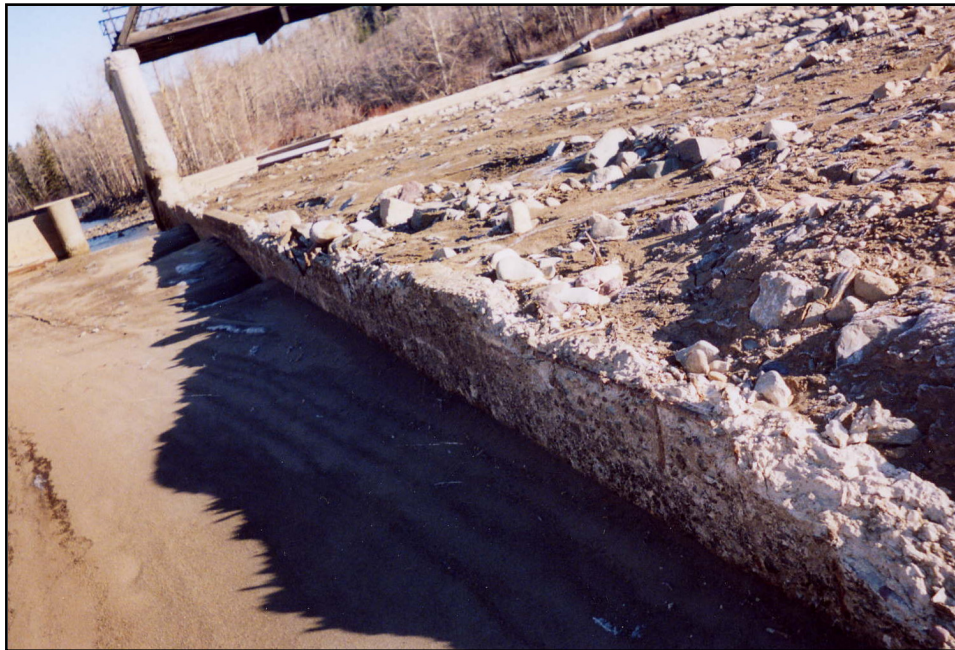
The concrete channel wall on the east side of the sluiceway (in front of the headgates) is in extremely poor condition where it is exposed (Figure 4.2.6). Most of the wall is hidden beneath sediment. The channel bottom was not observable.

Figure 4.2.6 Sluiceway training wall upstream of canal headgates (11/11/04).
